INCIDENTS THAT DEFINE PROCESS SAFETY

John Atherton, BP plc (retired)

Frederic Gil, BP plc

Center for Chemical Process Safety

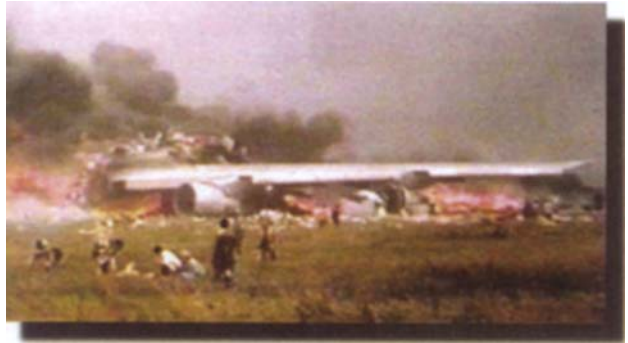
Tenerife, March 27, 1977, a Boeing 747 taking off collides with a Boeing 747 taxiing on the runway: 538 dead.

The investigation concluded that the most probable cause of the accident was that the KLM aircraft had taken off with the absolute certainty that it had been cleared to do so, through misunderstanding of communications.

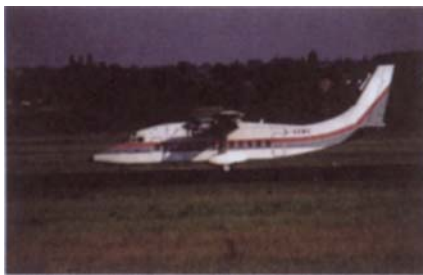
Shorts entered the runway at the same moment as the MD 83 was reaching its rotation speed. The MD 83's wing tip sliced into the cockpit of the Shorts killing one pilot and injuring the other. The MD 83 aborted its take off and was only slightly damaged. All persons on board, 6 crew and 151 passengers, survived the accident unharmed. The Shorts aircraft was severely damaged; it only had the pilot and co-pilot on board with no passengers.
