INCIDENTS THAT DEFINE PROCESS SAFETY

John Atherton, BP plc (retired)

Frederic Gil, BP plc

Center for Chemical Process Safety

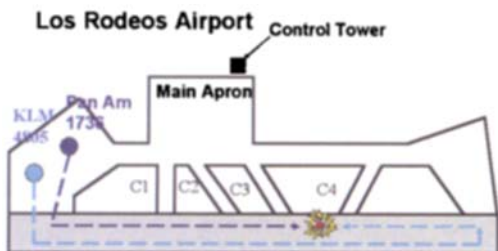
Three minutes later, Pan Am 1736, which had been holding short of the runway, was instructed to taxi along Runway 12 and to leave it at the third taxiway on the left, and to confirm when they had left the runway. The captain of the Pan Am found the air traffic controller’s (ATC’s) accent difficult to understand and asked for confirmation, which was given. Meanwhile, the KLM aircraft had reached the end of the runway and completed its turn, and was now facing the Pan Am flight. The KLM captain opened the throttles to start the take off, but was challenged by his first officer as to whether they had received final clearance to take off. This was sought while the KLM aircraft was held on the brakes. As the first officer was reading back the instructions given by the ATC, his captain released the brakes and KLM 4805 started the take-off roll. In order to let the ATC know exactly what was happening, the KLM first officer radioed “We are now at take off”. The ATC acknowledged, “OK, standby for take off, I will call you”.

This sequence of communications was causing extreme anxiety in the Pan Am cockpit, with the captain radioing to the ATC “No, we are still taxiing down the runway”. The ATC acknowledged the message asking for Pan Am 1736 to report back when it had cleared the runway leaving the

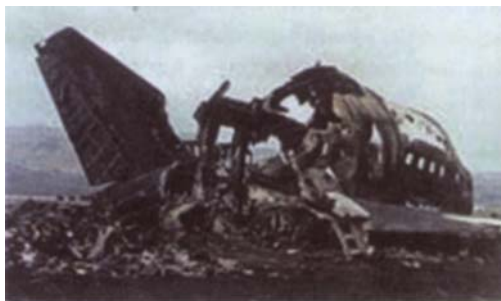
runway clear for the KLM flight to take off. However, the Pan Am crew were having difficulty identifying the third taxiway on the left, compounded with difficulties in understanding the ATC, and had in fact gone past it. What appears to have happened is that the KLM and Pan Am messages were sent simultaneously, with only the “OK” being heard by the KLM flight crew due to a loud noise lasting almost 4 seconds in the KLM cockpit. Confusion still remained amongst the KLM flight crew with their flight engineer now querying whether the

Pan Am aircraft was still on the runway. His concerns went unheard as the KLM aircraft accelerated into its take off.

Seconds before the impact, both aircraft flight crews saw each other. The Pan Am captain tried to pull his aircraft over to the right, while the KLM captain tried to climb. Despite leaving marks of a 65 foot (20 metre) "tail drag" on the runway, the KLM aircraft had attained insufficient speed to climb over the other Boeing 747, skidding over the top of its fuselage, and shearing off the tail. The KLM aircraft stayed in the air for only a few seconds longer before slamming down onto the runway and bursting into flames 500 feet (150 metres) further on.

The investigation concluded that the most probable cause of the accident was that the KLM aircraft had taken off with the absolute certainty that it had been cleared to do so, through misunderstanding of communications.

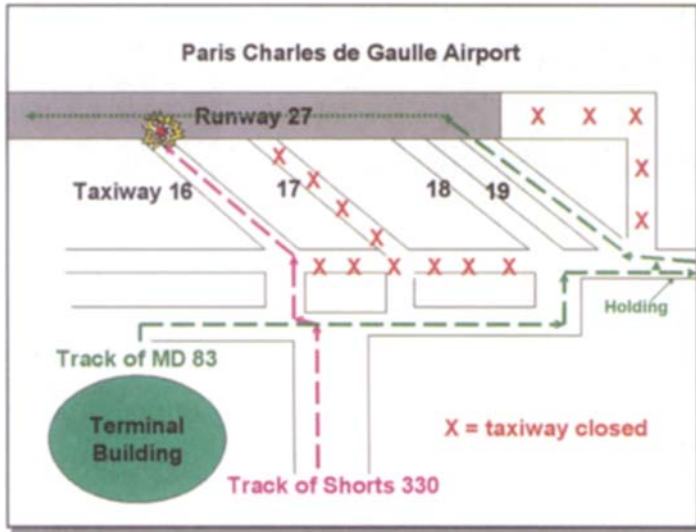
Boeing 737 had cleared the runway and the MD 83 given clearance for take off. Five seconds later the Shorts 330 was cleared to line up on runway 27 as

“number 2”, indicating that it should take off after the MD 83. However, the two aircraft were in different locations, with the result that the MD 83 was taking off from the end of the runway at the same time as the Shorts entered the runway at an intermediate point. The crew of the Shorts was looking for aircraft “number 1”, which was to take off before it, as they moved onto the runway. When they saw the MD 83 bearing down on them, they braked, but the MD 83 had by that time accelerated to the point where it could rotate and climb. It was at that point they saw the Shorts 330 and, despite the MD 83 trying to take, off three seconds later impact occurred. The left wingtip of the MD 83 struck the right hand propeller of the Shorts 330 and sliced through its cockpit.

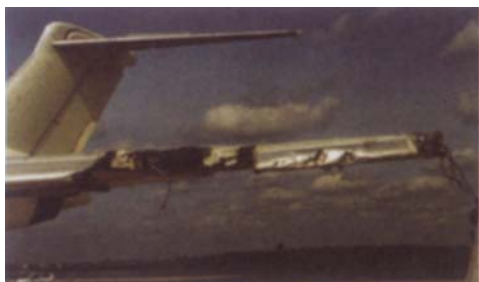
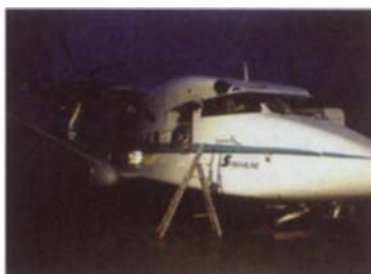
At the time of the accident, construction work at the airport had taken taxiway 17 out of service. This is located between taxiway 16 used by the Shorts 330 and the end of the runway. Taxiway 17 was barricaded from the operational areas by barriers and lit by halogen lights mounted about 3 metres (10 feet) above the ground pointing downwards. From 20:30 to 04:30 ten vehicles were working on taxiway 17, each with a flashing yellow light. Drizzle was falling at the time of the accident, which would have created random reflections of the working and yellow flashing lights possibly masking the anti-collision lights of other aircraft, otherwise the night was clear with light winds. However, the presence of a dip in the runway between the threshold and the point at which taxiway 16 joined, the lights from the construction and the background of lights from an airport terminal made it very difficult for the crew of the MD 83 to see the Shorts, particularly as they had no reason to look out for it.

The explanation of why the Shorts did not see the MD 83 until the last moment is to do with the angle at which taxiway 16 joins runway 27. Before lining up a pilot always makes a visual check of the runway to confirm that it is clear. However, taxiway 16 joins runway 27 at an angle of 20° to allow high speed exit of landing aircraft. The Shorts 330 has a visual field that extends 120° to either side of the centre line. Simple geometry shows that the Shorts 330 would have had to make at least a 40° turn to the right to have had any chance of seeing the end of runway 27. Measurements taken after the event showed that there were no fixed obstacles at the height of the Shorts cockpit windows that would have obscured the end of the runway from the point at which taxiway 16 entered the runway.
